Development Testing and Subsequent Failure Investigation of a Spring Strut Mechanism

Abstract

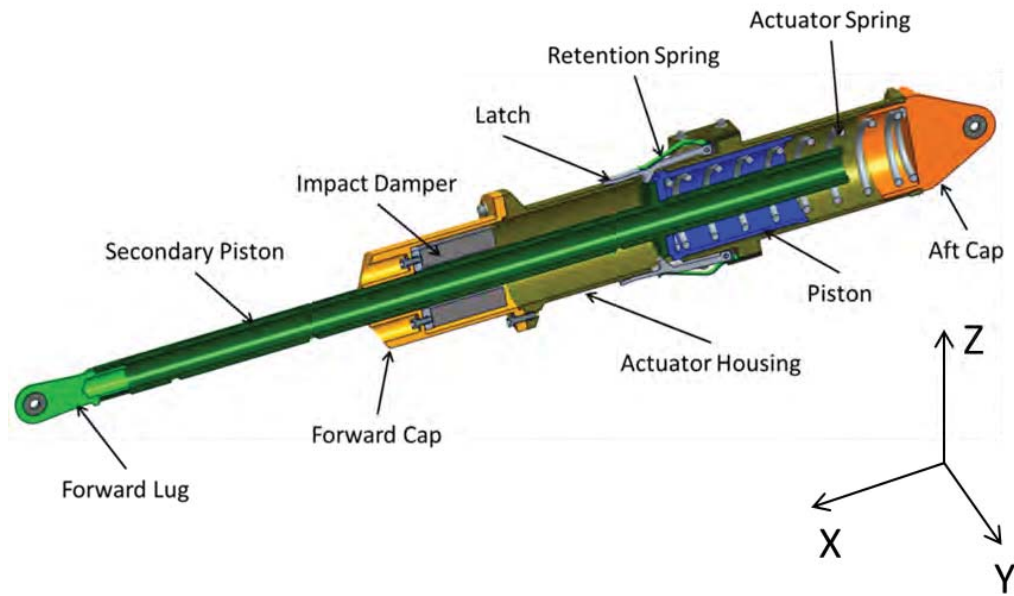
Figure 2. MPCV CM-SM Umbilical Spring Strut Detail Cross Section

The CM-SM umbilical spring strut consists of multiple piece parts assembled with sliding contact interfaces. A detailed image of the assembly with piece parts identified can be found in Figure 2. The titanium actuator spring is compressed when configured to the strut flight length (780 mm (30.7 in) between end fitting spherical bearings). The compression force is applied to the aft cap, located on the SM side, and piston located internal to the actuator housing. The piston transfers the load to the secondary piston through a contact constraint normal to the strut axis. The contact surface between the piston and secondary piston is permitted to rotate relative to one another and is only opposed by friction. When the strut is permitted to actuate, after release of the umbilical interface at the CM, the compressed spring forces the piston forward sliding through the actuator housing and driving the secondary piston forward. Dual spring-loaded latches slide over the piston as it moves through the actuator housing. Once the piston traveled past the latches, the latches are forced into the actuator housing cavity prohibiting the piston from returning to its pre-actuation position. During the actuation, the driven secondary piston will move until it contacts the aluminum honeycomb damper dissipating the energy of the forward stroke.

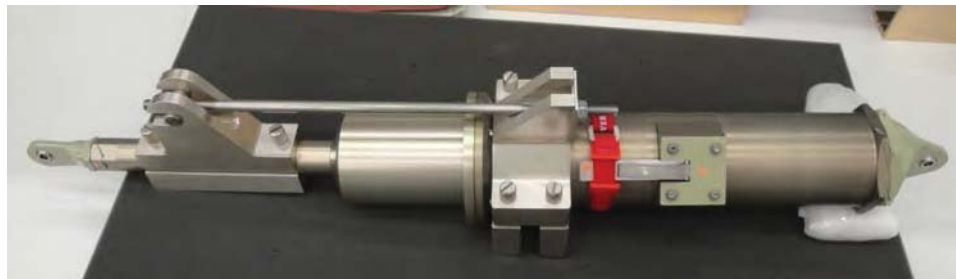
Figure 3. CM-SM Umbilical Spring Strut with Retention Tool

After compressing the strut to the stowed flight length, a retention tool (shown in Figure 3) was applied to sustain the compressed state of the strut. The retention tool interfaces with two through tooling holes located in the secondary piston and the body of the actuator housing. The tool was applied after initial assembly, after pre- and post-random vibration performance testing, and during reconfiguration between random vibration test axes.

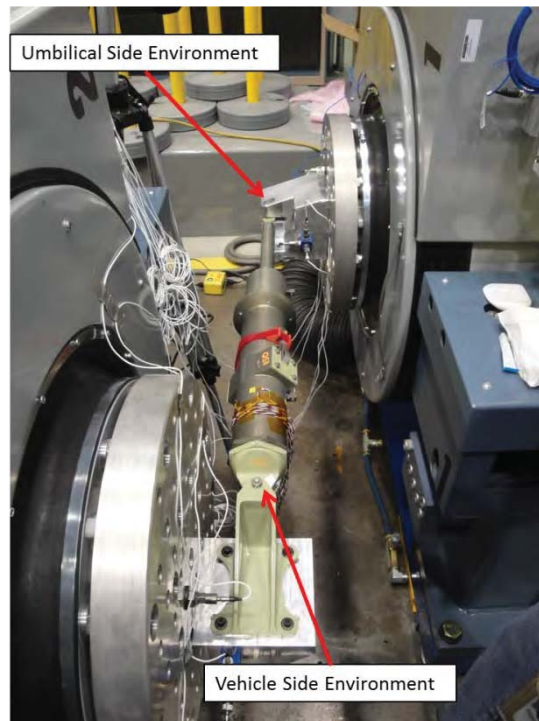
Figure 4. Dual Shaker Configuration (Z-axis)

Two random vibration environments in each axis were provided by LM for the umbilical and SM side inputs. Several options were initially evaluated for the random vibration test configuration before reaching an agreement to utilize two T-2000 Unholtz-Dickie 80068 N (18000 lb_f) shakers with two shaker control systems and two random vibration environments applied simultaneously and uncorrelated. By using two shakers, the umbilical strut was exposed to the required environments and was the closest to qualification of a “flight-like” configuration. The dual shaker configuration can be found in Figure 4.

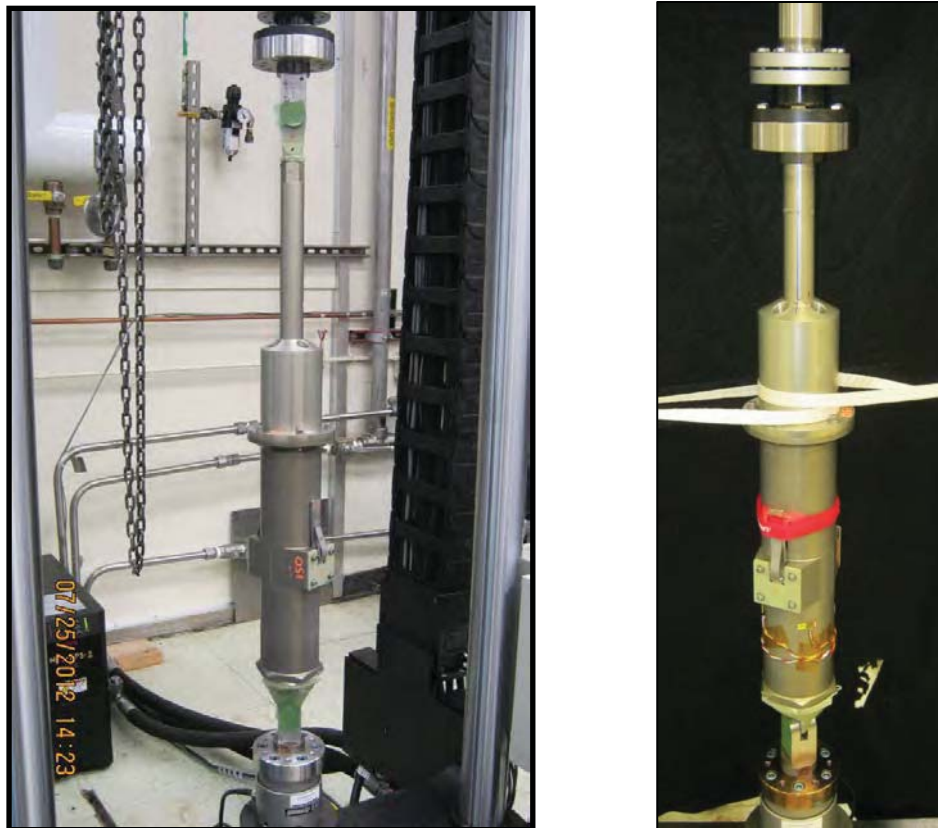
Figure 7. Test Setup for Performance Testing (Pre-Vibe [left] and Post-Vibe [right])

In the performance test, the development spring strut was exercised at a slow rate from the flight configuration (stowed) to the extended position (Figure 7) to measure the load versus displacement characteristics and observe the function of the anti-back-travel latches. In the wear-in test, the strut was

After failure during the random vibration testing, the strut was returned to the performance testing facility with a truncated secondary piston to remove the failed portion of the strut. Using a cupping interface, post-vibe performance deployment tests were performed with the strut assembled in the load frame. The post-vibration performance test served primarily to assess whether there were any large excursions from the nominal force-deflection curve. These excursions could be indicative of significant damage to the spring strut sliding surface. The post-vibration performance test satisfied the nominal expected end of travel force of $165 \text{ N} \pm 27 \text{ N}$ ($37 \pm 6 \text{ lbf}$) and resulted in nominal engagement of the anti-back travel latches. Force versus displacement within the expected tolerance yielded acceptable force margin based on the next high assembly assumptions and calculations. A comparison of the pre- and post-random vibration performance test is shown in Figures 8.

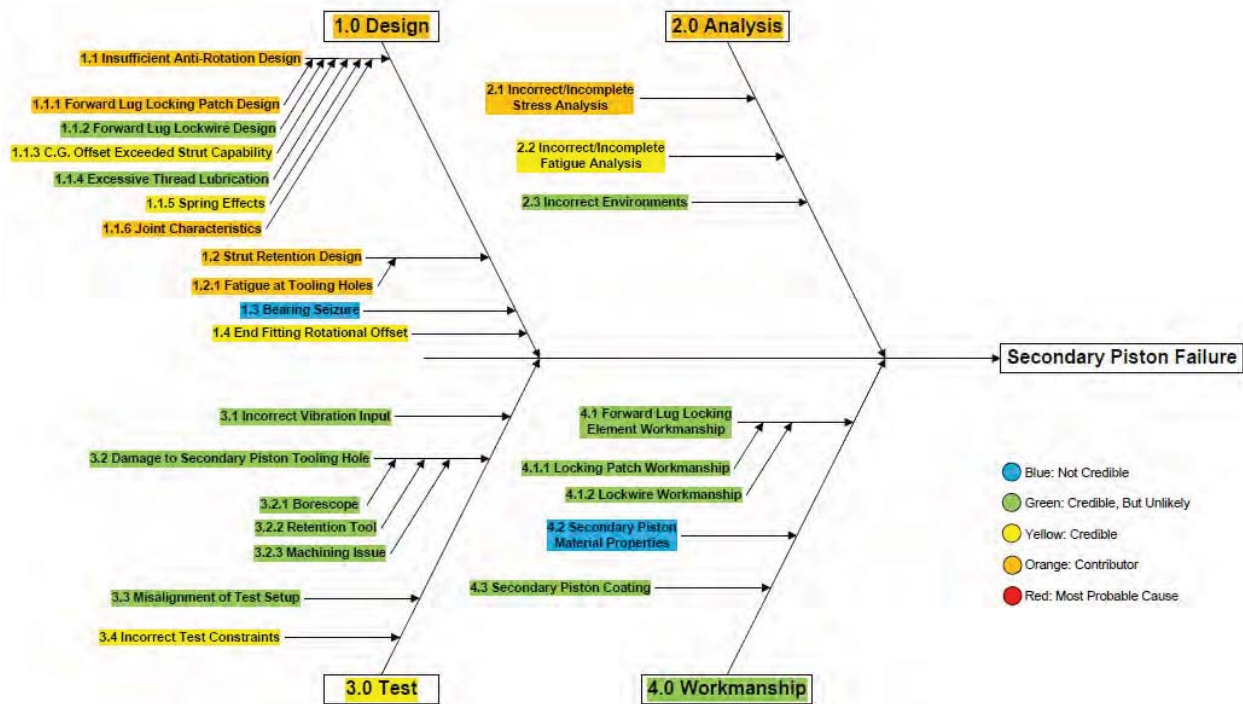
Figure 9. Fishbone Diagram

Immediately following the strut failure, the joint NESC and LM team generated a fishbone diagram. Individual elements were classified as aspects of design, analysis, test, and/or workmanship. Related and supporting evidence was gathered to disposition those elements as either most probable cause, contributor, credible, credible but unlikely, or non-credible. The NESC/LM joint investigation occurred over a month whereupon, due to MPCV Program schedule pressure, LM chose to implement corrective actions addressing identified proximate causes and assumed ownership of the CM-SM umbilical spring strut development test program. The NESC team continued the investigation in an effort to identify root cause and the most probable failure scenario. Supporting analyses were completed, photographic evidence was reviewed, and inspections were conducted to provide rationale for fishbone element classifications shown in Figure 9. Detailed information regarding the root cause investigation, including classification definition, can be found in the full NESC assessment report [1].
